Manhole Inspection Summary

Manhole # S57K__015MH

Insp Date: **2/6/09 9:06 AM**

Location Address: **3916 FOSTER-FAIT-ALLEY**

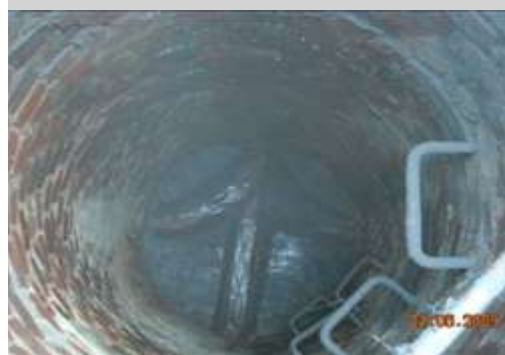
Top View

Comments **REMOVED COVER BY CUTTING AN EXPANSION GAP THROUGH THE CENTER OF THE LID. WAS THEN ABLE TO FORCEABLY REMOVE WITH DIGGING BAR AND 16LB MAUL.**

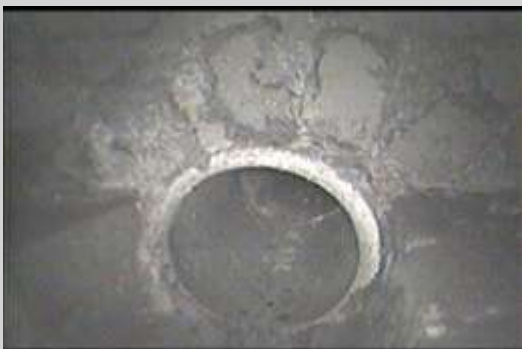
3 O'Clock Inflow

Pipe Height: **6** (in.) Rod and Bar (Angled)
Pipe Material: **Clay** ☐ Pipe Lined
Invert Depth: **10.45** (ft.) Flow Characteristics: **Slow**
Deposits: ☒ None ☐ Mud ☐ Sludge ☐ Debris ☐ Grease
Silt Depth: **0** (in.) Deposits Extent:
Infiltration: **None** Pipe Seal Cond: **Sound**

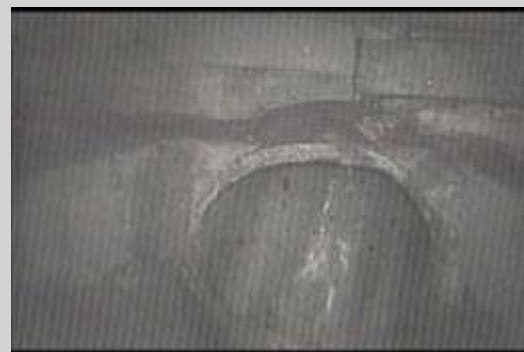
Drop In @ 9 O'Clock

Drop: **Outside** Rod and Bar

Angled: **Yes** Reading: **9.84** (ft.)

Drop Condition: **Open**
